S1740-AK-RPT-010

U.S. NAVY SALVAGE REPORT EX-USS *PRINZ EUGEN* OIL REMOVAL OPERATIONS

PUBLISHED BY DIRECTION OF COMMANDER, NAVAL SEA SYSTEMS COMMAND

APRIL 2019

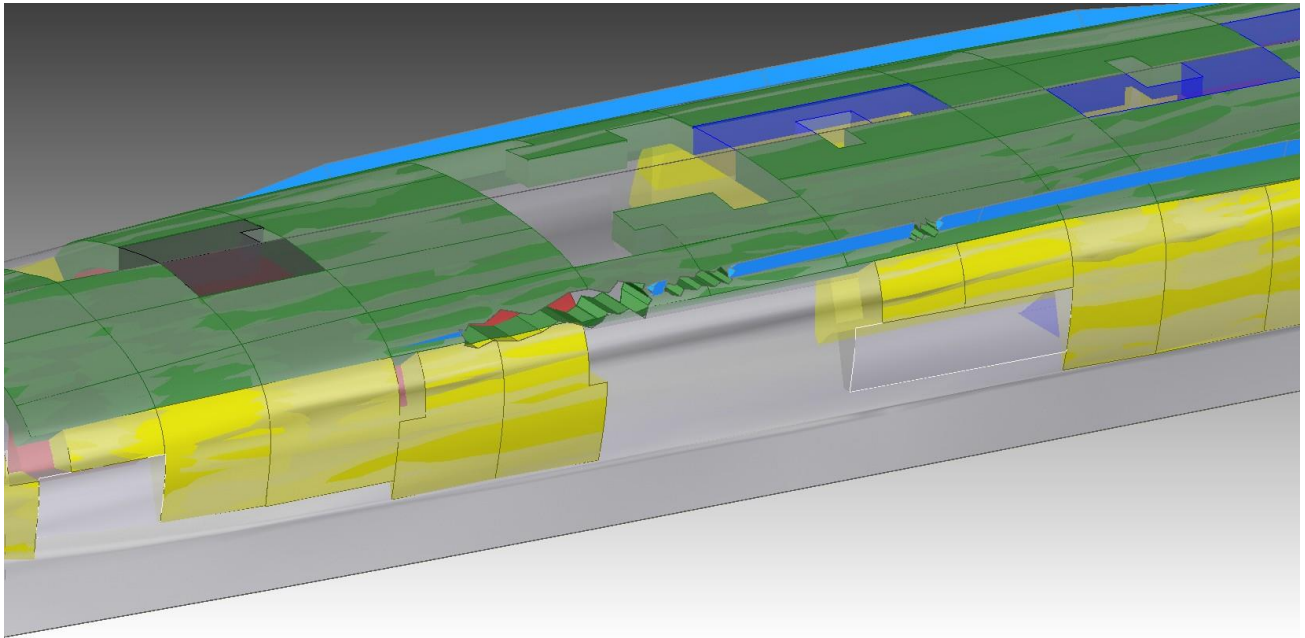
Figure 3.10. 3D Model Showing the Location of Damaged Hull Sections
Port Side Aft along Bilge Keel
Damaged ship areas (though not details of the actual damage) and internal
tank locations were drawn in 3D models to assist with planning tool
design as well as to determine oil estimates.

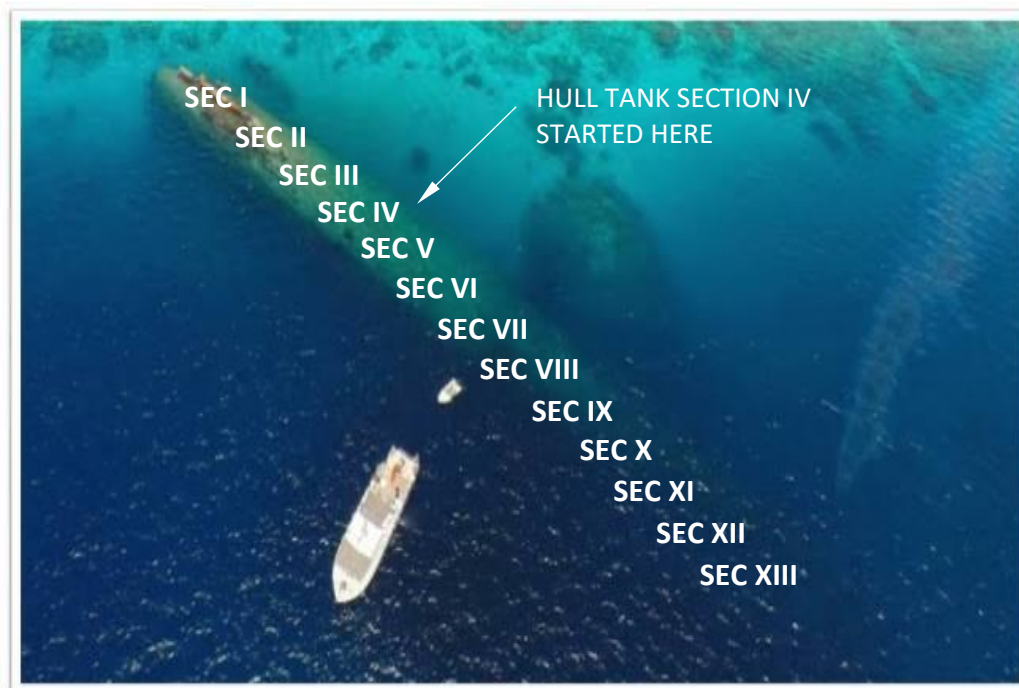
Figure 4.23. Overhead View of ex-USS *PRINZ EUGEN* Wreck with Sport Diver Boat near Amidships. Date of photo is unknown, note oil leaking from bow. The general location of Sections I through XIII is overlaid on the photo.

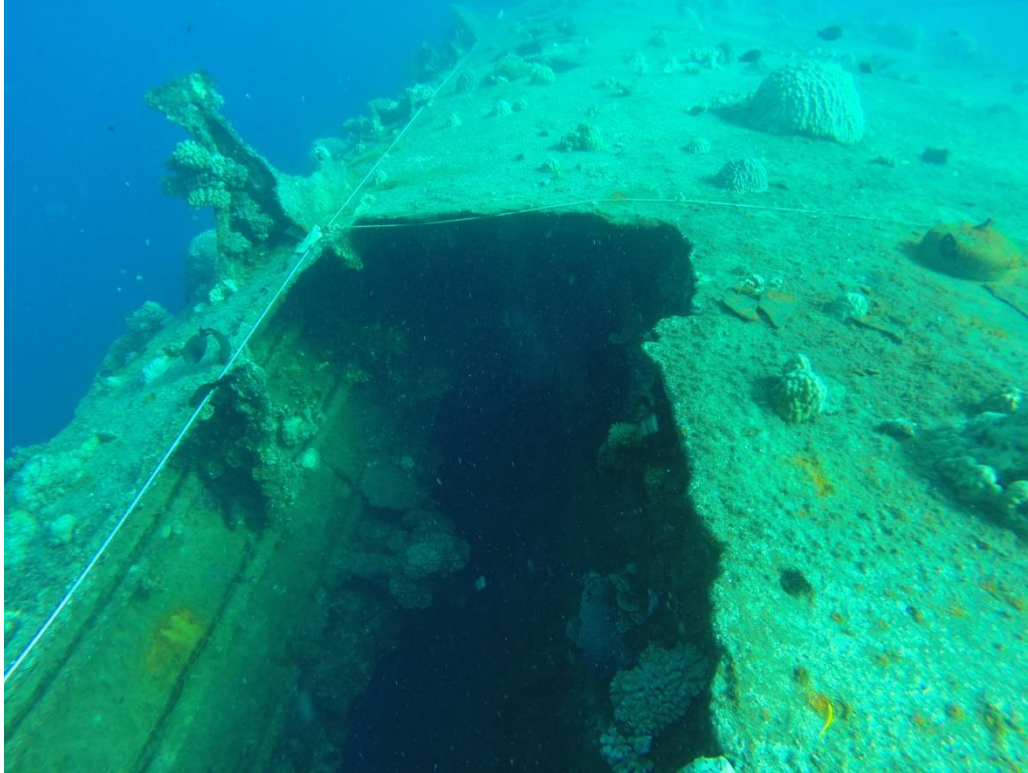
Figure 4.41. This photo gives a good representation of some of the damage and wastage on the aft hull. This is most likely a view of the port side bilge keel (what is left of it) looking aft (uphill) around tank section IV frame 76.75.

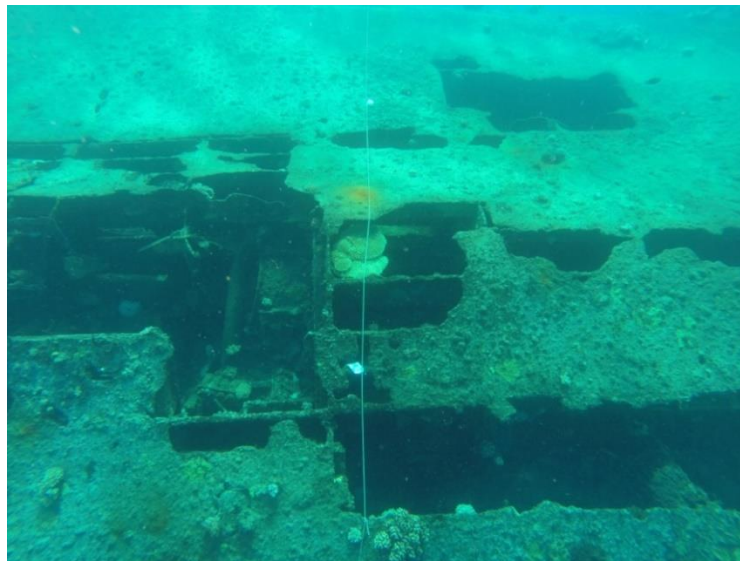
Figure 5.2. Stern Sections Wasted Metal

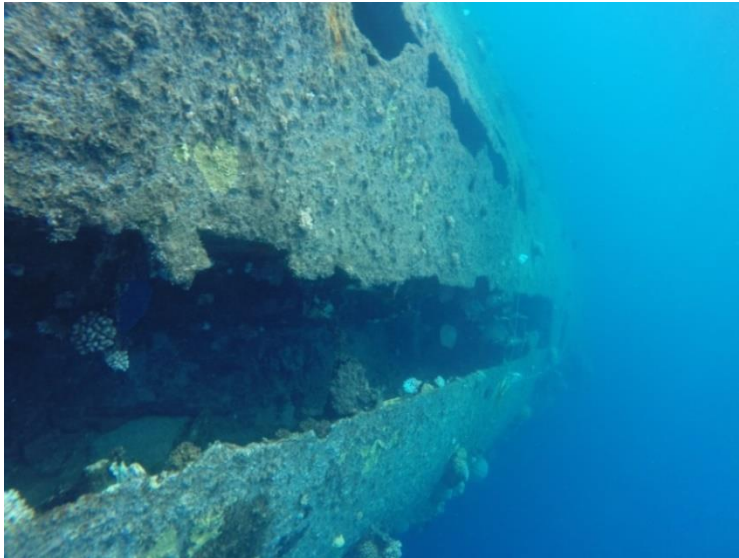
Figure 5.3. This photo shows the hull damage of Section II below the turn-of-the bilge, which is most likely from the original collision.

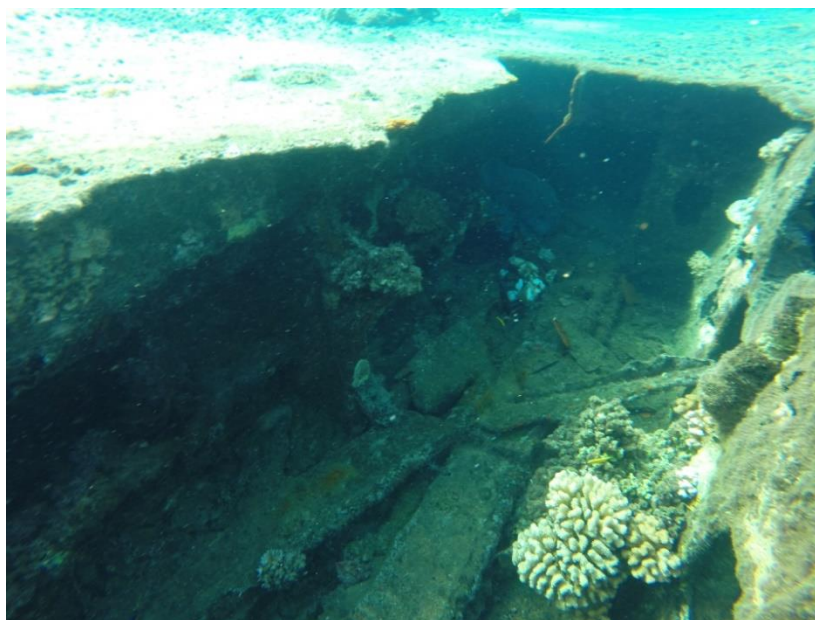
Figure 5.4. Hull Damage Port Side Aft, Estimated to have Originated from Collision with the Reef

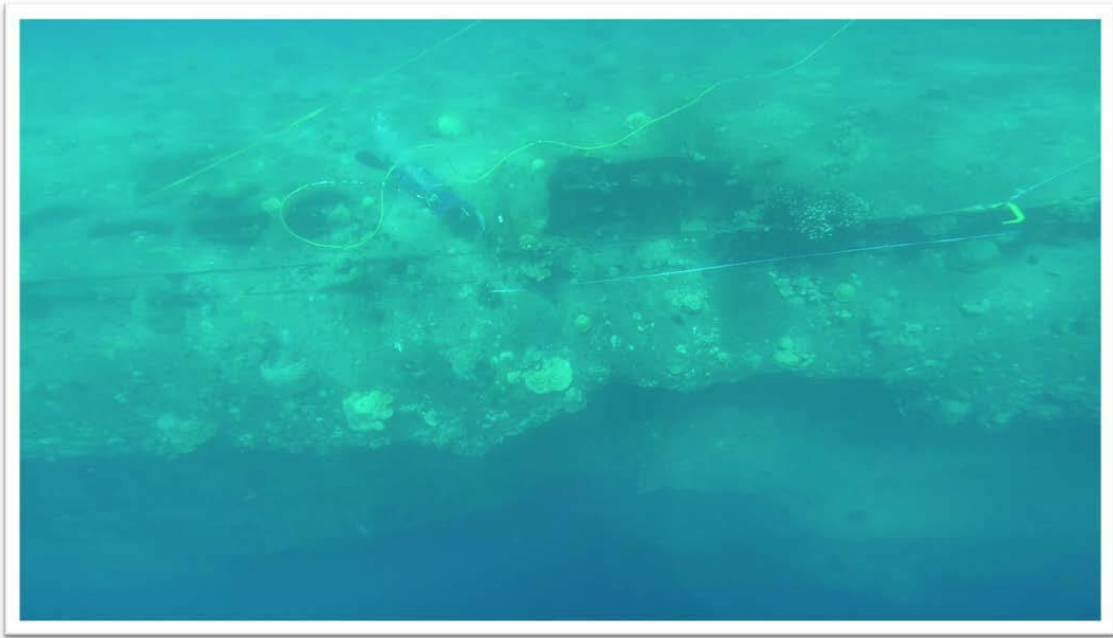
Figure 5.5. Photo from 2017 Survey Damage Aft and Below Bilge Keel
Hull Sections III, IV, and into Section V

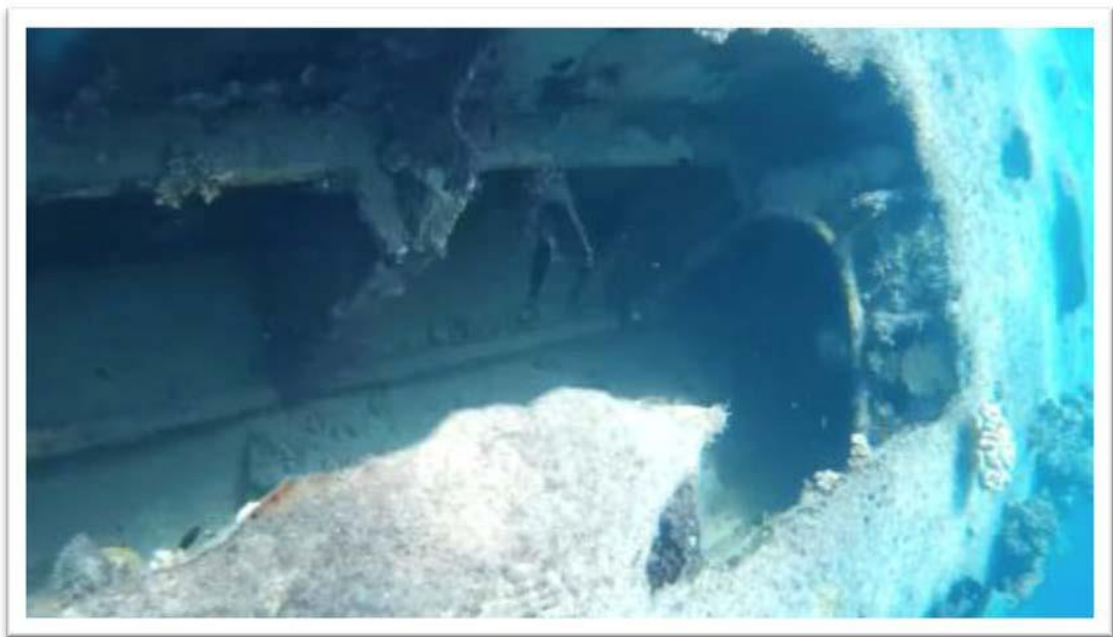
Figure 5.6. Aft Below Bilge Keel (2017 Survey Photo)

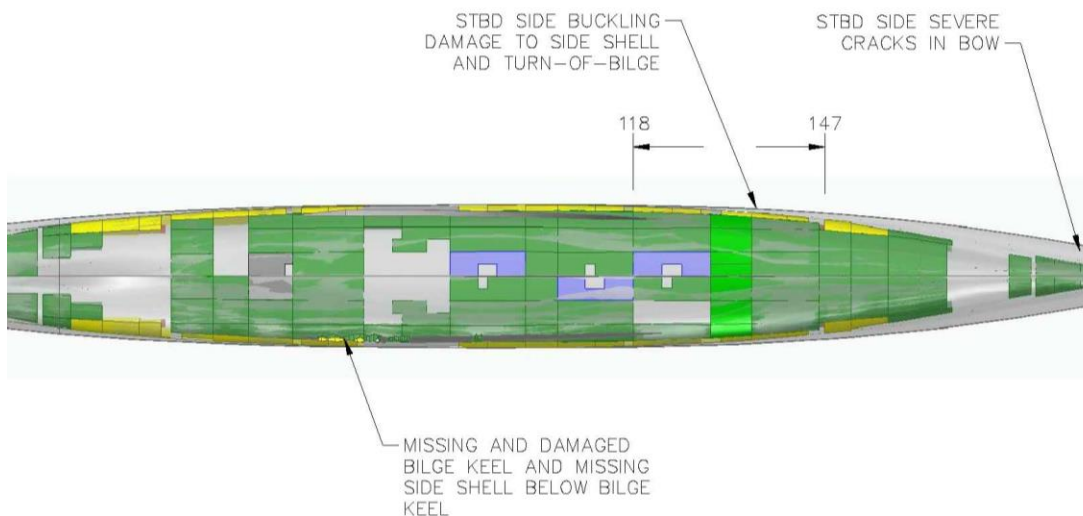
Figure 5.7. Hull Model Showing Heavily Damaged Areas of the Hull

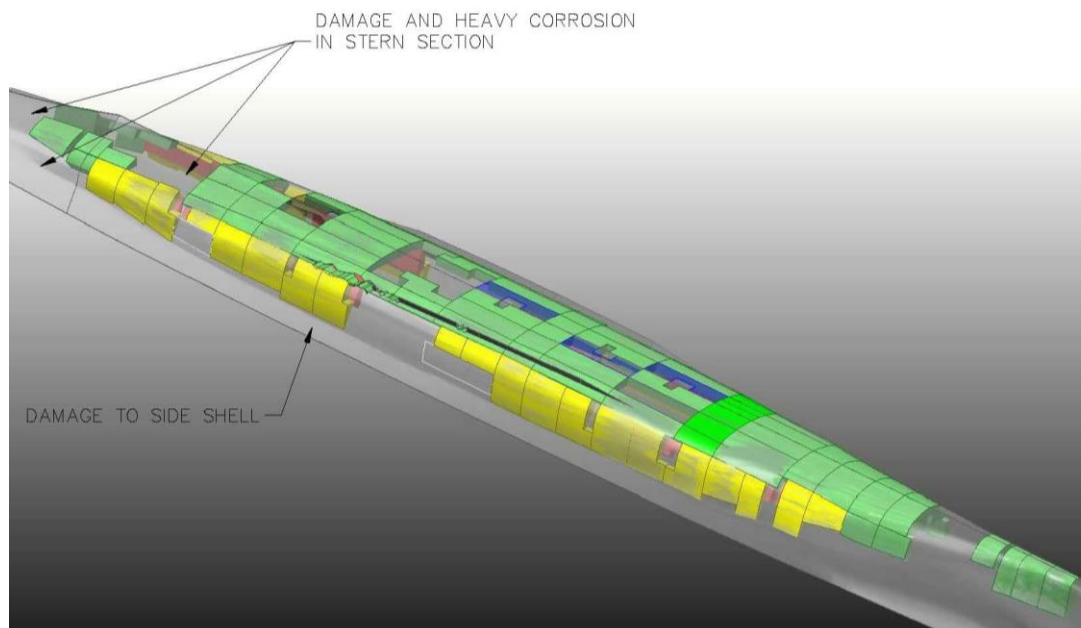
Figure 5.8. Hull Model with Damaged Sections Pointed Out at Stern and Port Side

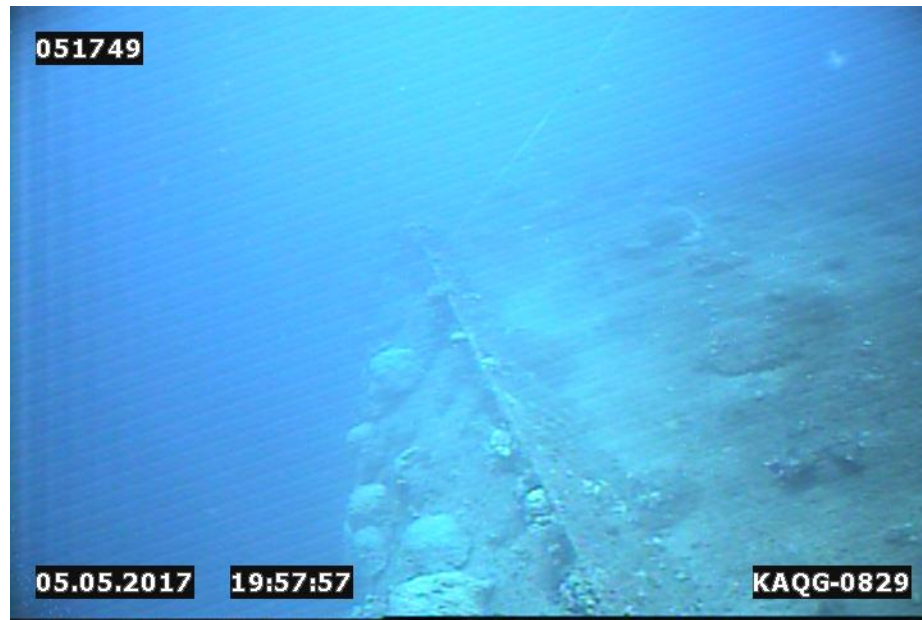
Figure 5.10. Port Side Looking Aft Along the Bilge Keel Forward of Section V and VI
The bilge keel is intact, the hull metal is much thicker and there is much less corrosion.

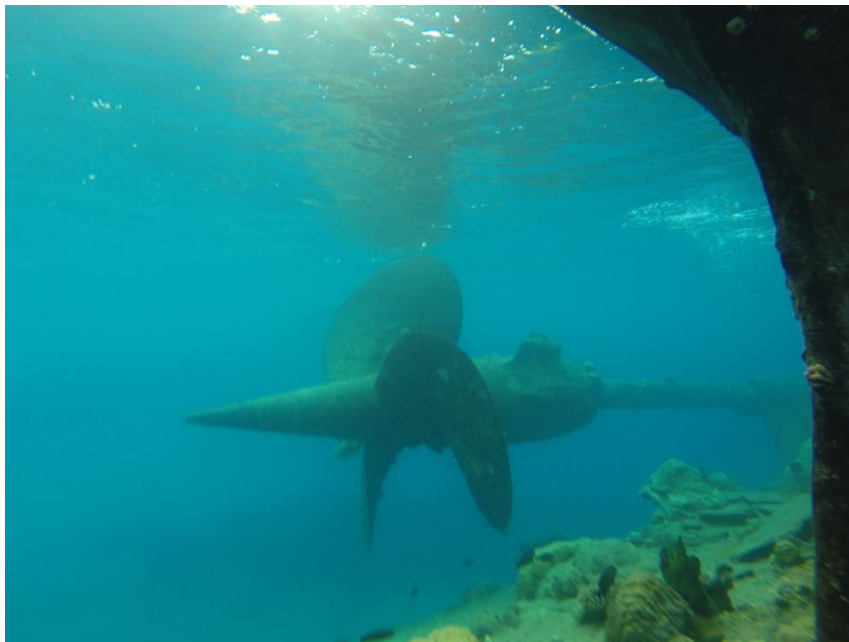
Figure 5.11. Starboard Propeller Shown with Missing Strut
The port propeller is missing and the center propeller extends partially out of the water.

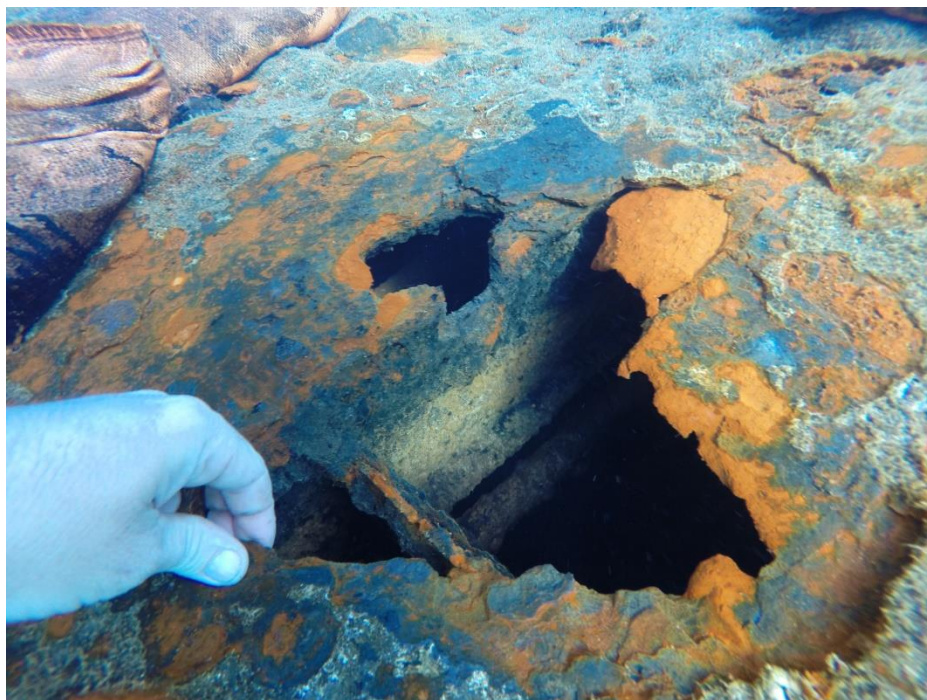
Figure 5.12. Stern sections (hull Sections I and II) are wasted away in many areas and are very thin.

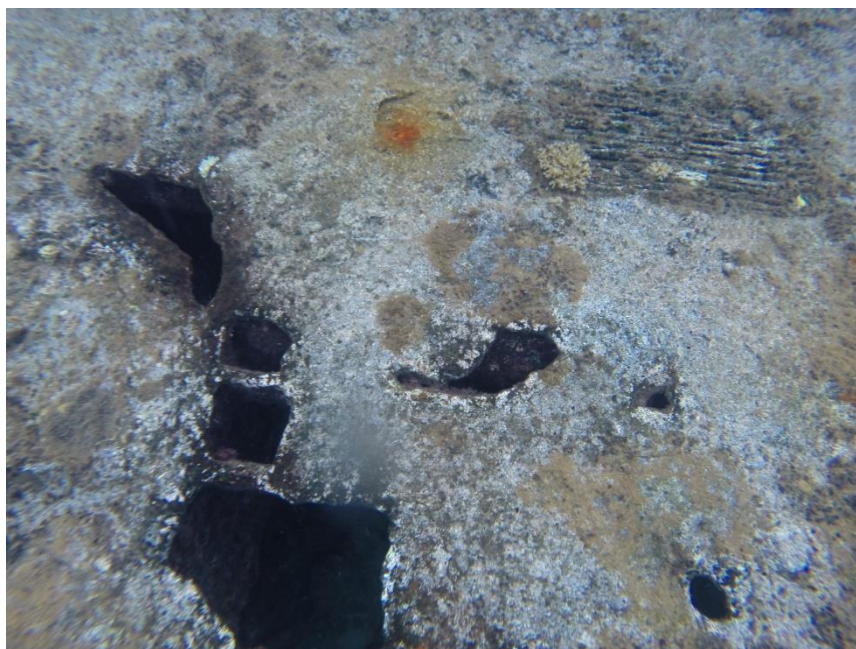
Figure 5.13. Heavy Corrosion and Wastage in the Aft Sections;
Note Sea Chest Inlet in Upper Photo

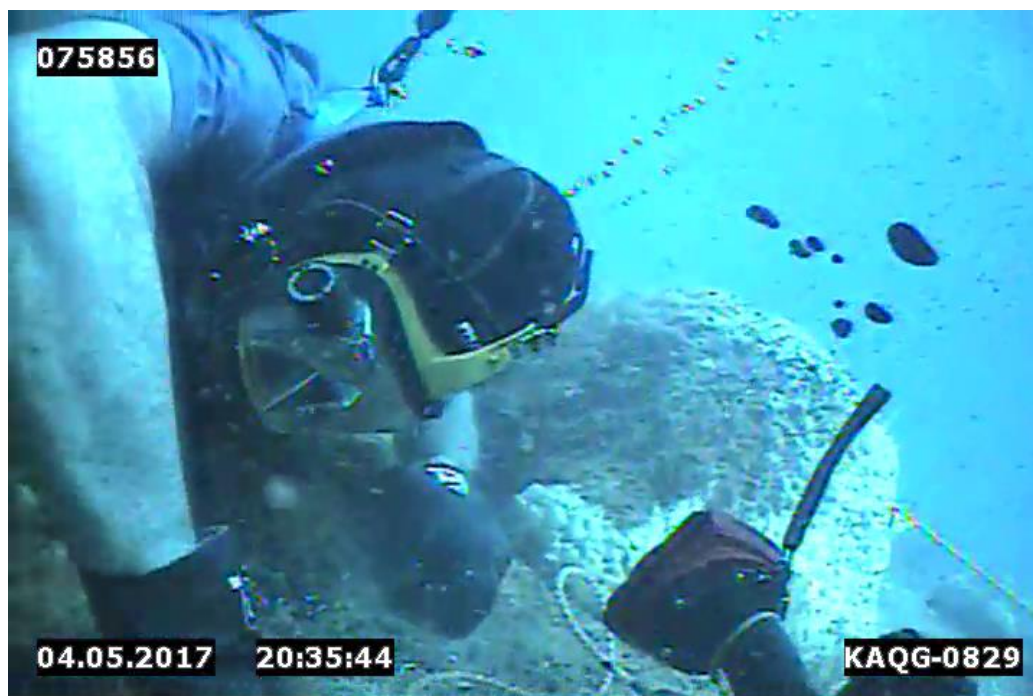
Figure O-2. Diver from 2017 Survey is Test Drilling (Note Leaking Oil Globule) and Measuring Hull Thickness with Cygnus Gauge
(Photo Taken 5 April 2017)
